## **Urgent Field Safety Notice**

### **Bugzi**

## **Urgent Field Safety Notice (FSN)**

## Reason For Field Safety Corrective Action

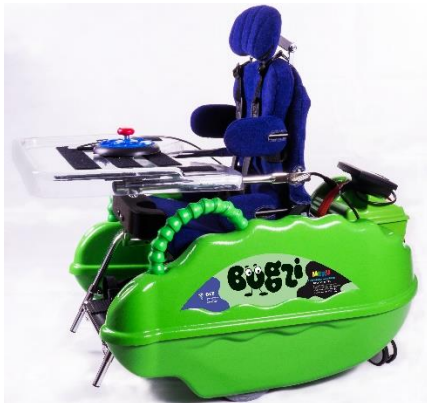
Figure 1: Bugzi - Childrens powered wheelchair

We would like to inform you about a Field Safety notice (FSN) affecting occupant safety on all Bugzi units. Bugzi is a small, green powered wheelchair (fig. 1.) , which is intended for use by children typically between the ages of 2-7 years. Bugzi is an indoor powered wheelchair which is intended for use in the home and school environments to facilitate mobility.

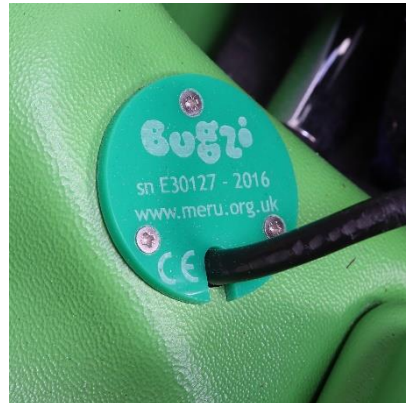
Figure 2: Serial number plate

The serial number of the Bugzi is shown on the small round plate located on the rear of the Bugzi, to the left of the battery unit, as shown in fig. 2.

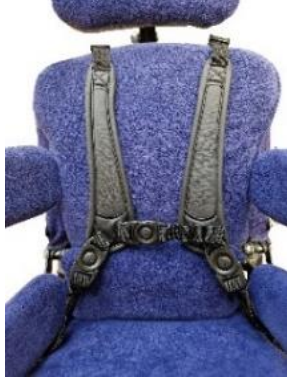
Figure 3: MiniCAPS Harness

**Active Design MiniCAPS seating** – The chest harness (fig. 3.) and grey mesh (shown in fig. 4.) might not meet the current safety standards for flame resistance. All seats have this harness, however only some seats supplied with the Bugzi will have the grey mesh.

**Active Design MiniCAPS seats** – If the harness or grey seat cover is exposed to a source of ignition, there is a possibility that the harness or seat cover may ignite, causing burns to the user/patient and others. This presents the potential risk to the user and others of serious injury or risk to life. Potential patient risk ranging up to serious injury or risk to life, and a potential user risk ranging up to serious injury.

The non-compliance with current flammability standards was identified during laboratory testing. We are unaware of any in-field incidences of ignition of the harness or grey mesh cover and are therefore unable to accurately estimate the probability of risk associated with this occurrence.

**Active Design MiniCAPS seats** – We submitted 2 different samples from different batches of the MiniCAPS seat for testing. The grey mesh on one of the samples failed the flammability test. The harness on both samples failed the flammability test. We have notified Active Design Ltd, the manufacturer of these seats, of these results. As Active Design are unable to supply information about which seat batches are affected, we have taken the decision to issue this FSN for all Bugzi units.

We will arrange for collection of all Bugzi battery units, and Active Design seat harnesses from your home or care/education facility. We will replace the affected parts on the battery unit. We will replace the harness with a similar product that meets the required flammability standard.
